SUBJECT: F/V *Lou Denny Wayne* vessel grounding and recovery assessment

NAME AND DESCRIPTION OF VESSEL: F/V *Lou Denny Wayne*, 37-foot wooden-hull, crab fishing vessel

**Damage assessment and site characterization of the rocky shore
following the grounding and recovery of the F/V *Lou Denny Wayne***

February 25, 2008

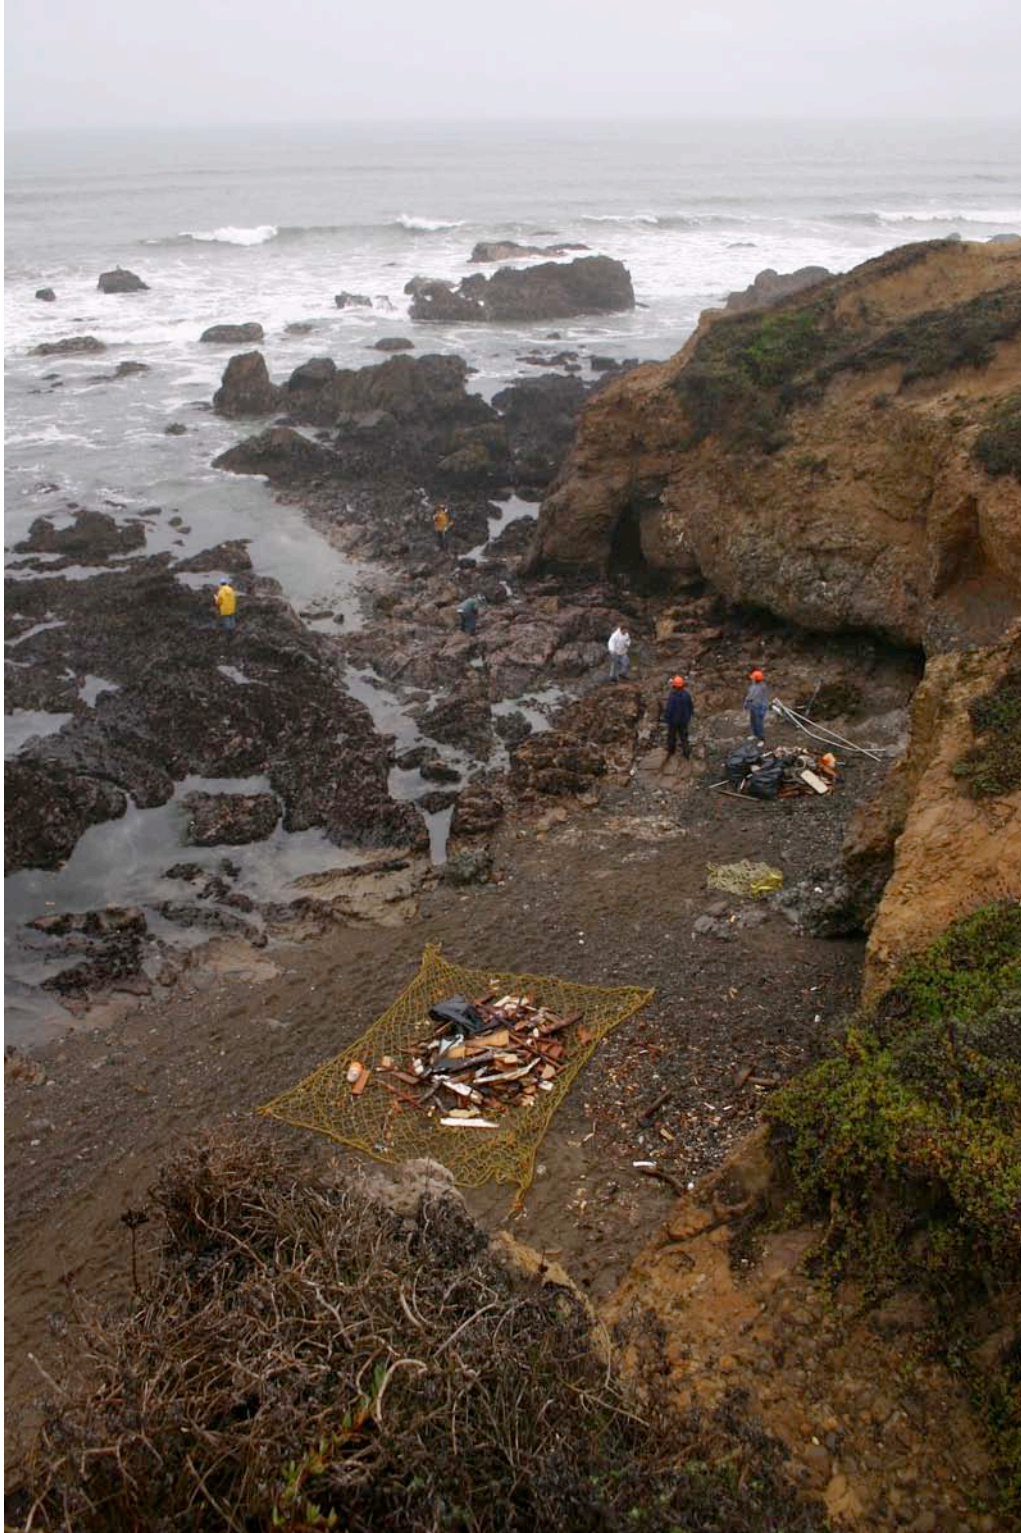
Figure 5. Removal of trash from F/V *Lou Denny Wayne* grounding site (12/06/07).

On December 6, 2007 research staff from MBNMS evaluated the site from 1400 to 1530 hr when the tidal height was -0.23 ft at 1438 at Ano Nuevo Island (Fig. 4). During the first 30 min a contracted helicopter hauled away three net loads, and shortly thereafter the rest of the cleaning crew left the scene (Fig. 5). The boat's engine had just been removed and some residual diesel spilled during transportation (Scott Kathey, personal communication). A slight sheen was visible on the surface of the water closest to shore, and it was also evident in at least one small tidepool (<1 m²) where there was a strong smell of fuel and an oily sheen (Fig. 6).

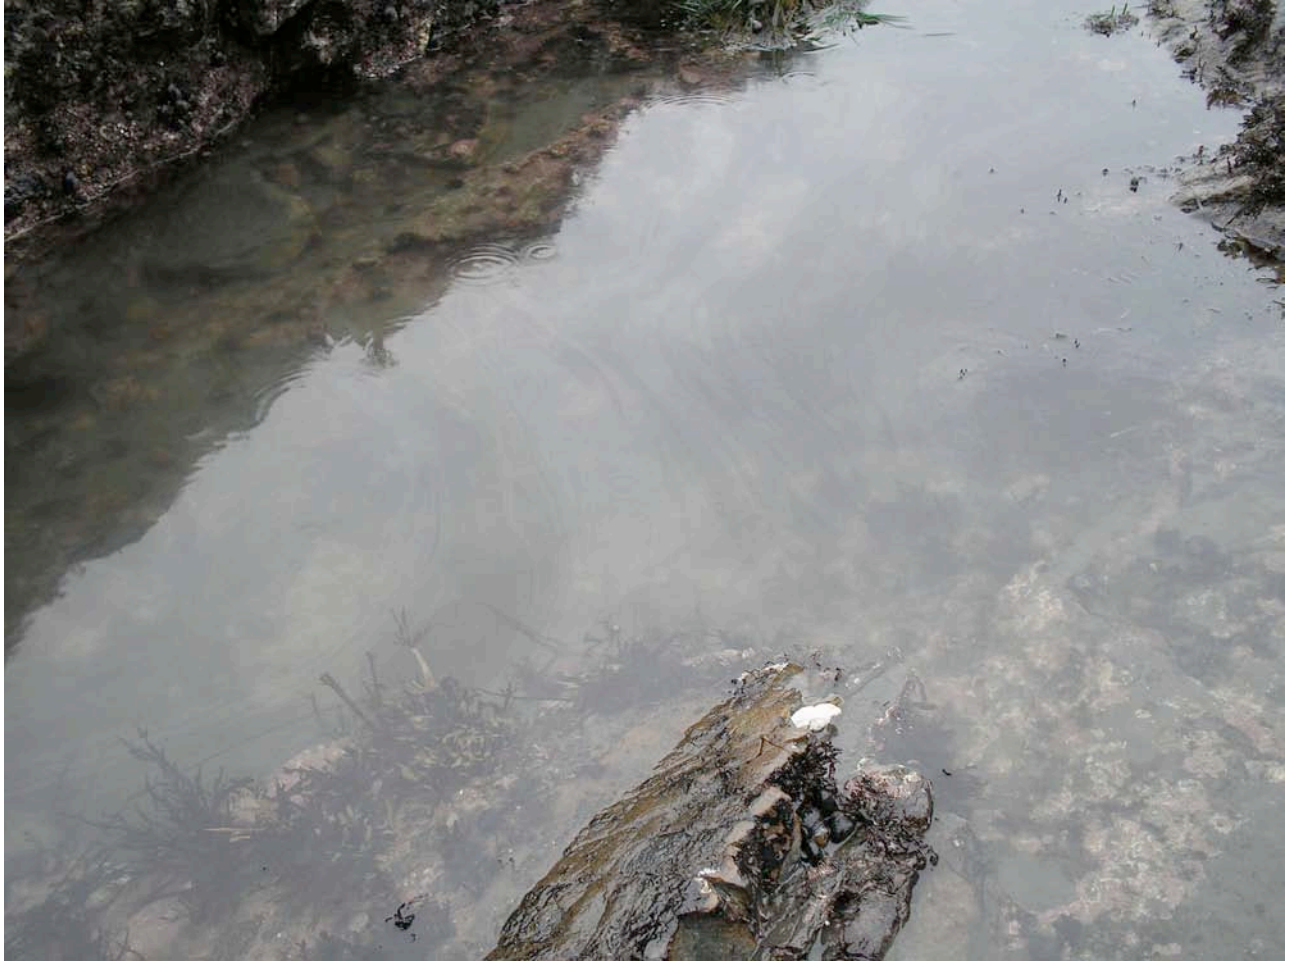
Figure 6. Oil sheen at F/V *Lou Denny Wayne* grounding site (12/06/07).

Damage from the grounding and recovery appeared to be minimal (e.g., approximately 10 m² of freshly broken sedimentary rock exposed at low tide; slight differences in percent cover of algae and invertebrates between survey transects). A diesel sheen was present in tidepools and the surrounding area during the December 6 survey. Small pieces of trash were also observed in the subtidal and wash zones. The site will be revisited in the future to monitor changes at the three transects.

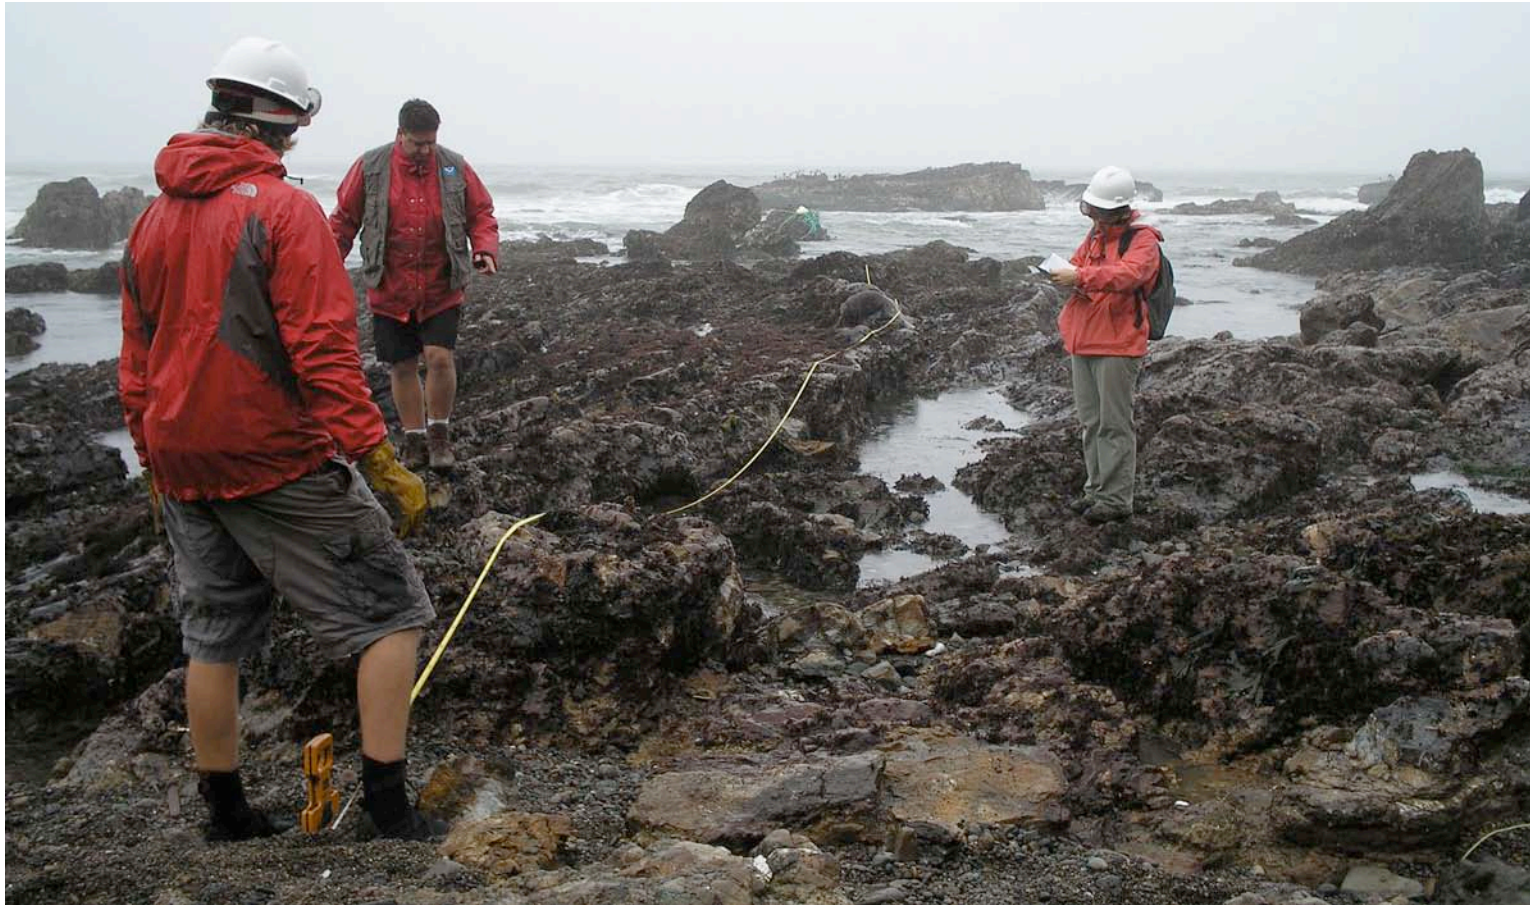
On December 6, 2007 researchers laid three transects running perpendicular from shore to sea. The LDW had settled into a channel very close to shore. Researchers placed transect 1 on the southern side of the channel in an area that was less impacted (qualitatively) than the northern side of the channel (Fig. 8). Transect 2 was on the northern side of the channel, an area that appeared to have the highest amount of freshly broken rock, both as cobble pieces and as newly exposed rocky shore (Fig. 9). Transect 3 was on the southern side of the main cove, 30 m south of transect 1 and further away from the impact site than transect 1; this served as an undisturbed reference (Fig. 10). Percent cover data are summarized in Table 1.

Figure 8. Transect #1 on southern side of channel. An area that appeared to be less impacted than the northern side of channel (12/06/07).

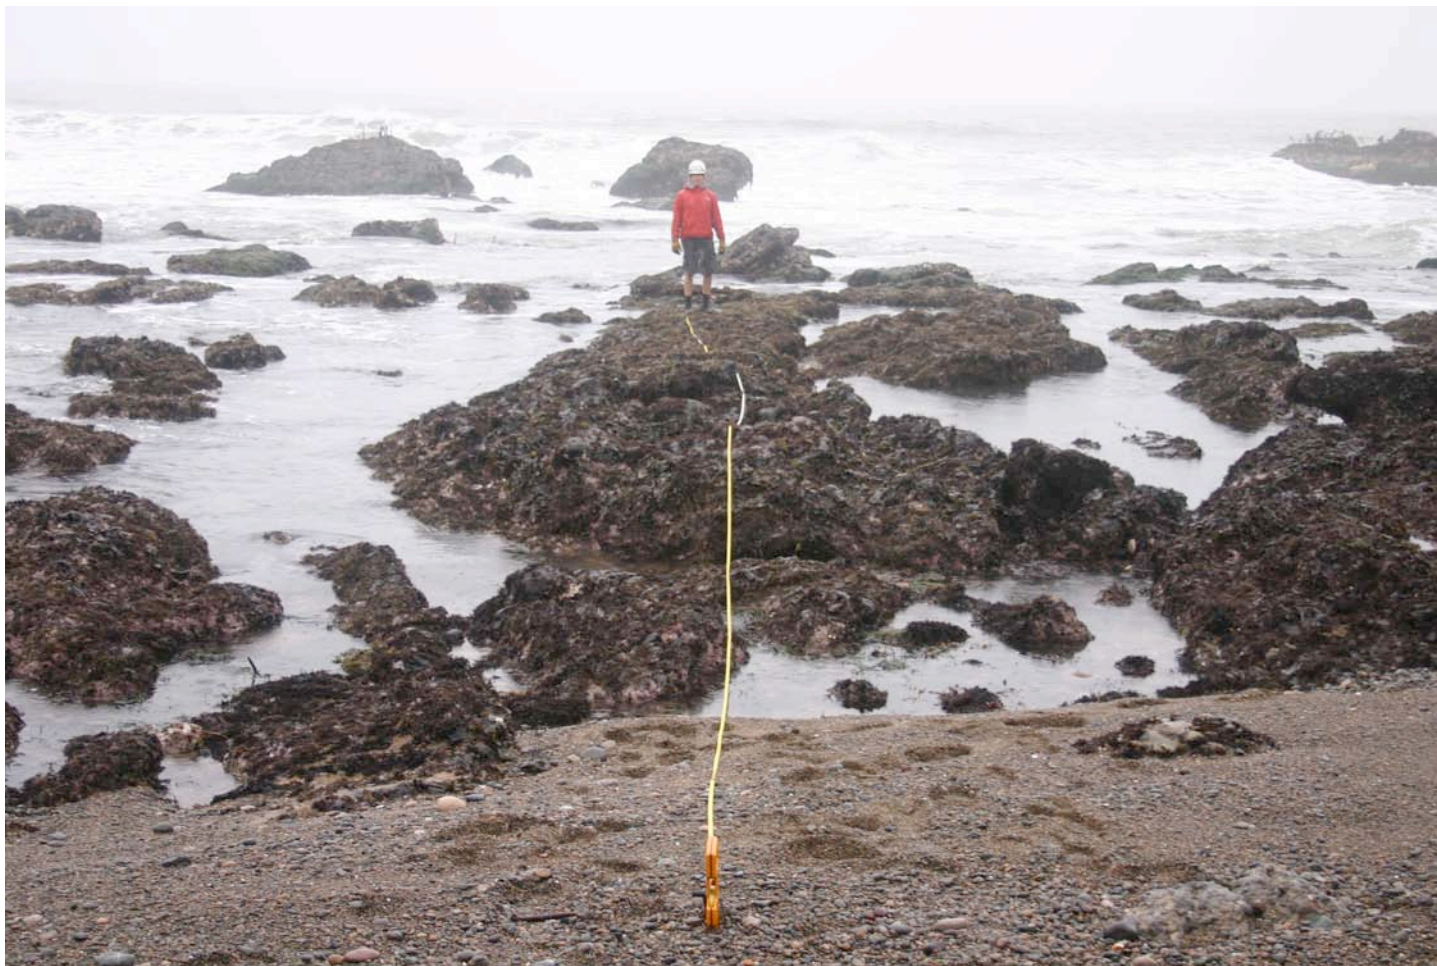
Figure 10. Transect #3 on southern side of main cove served as undisturbed reference site (12/06/07).
