Site Damage Assessment: Sunken F/V *Stikine*

Andrew DeVogelaere
& Oren Frey

Monterey Bay National Marine Sanctuary
99 Pacific Street; Building 455a
Monterey, CA 93940

June 2012

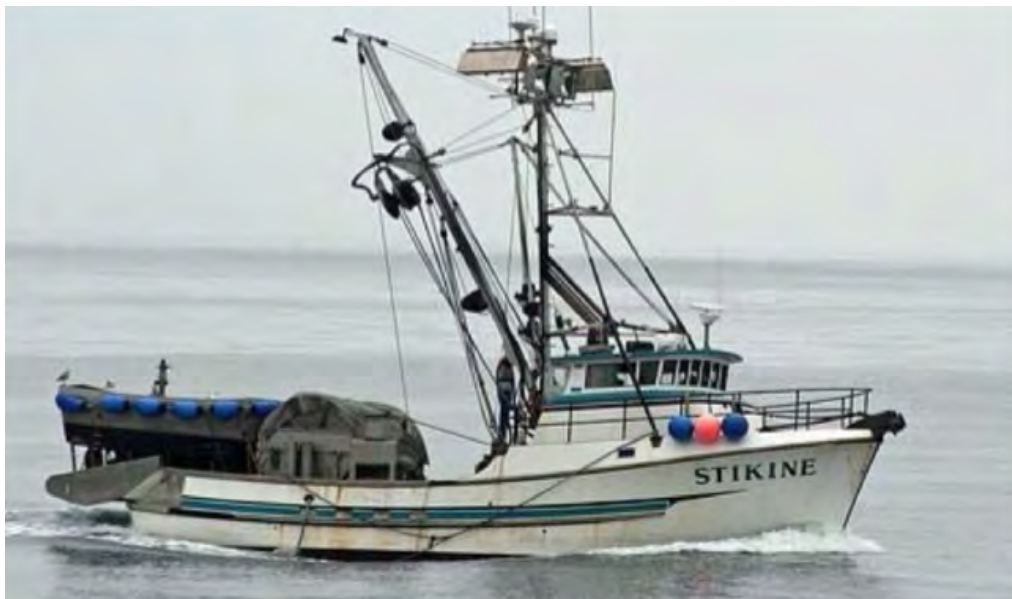
Figure 1. The F/V *Stikine*, a 58' purse seiner, sank on January 6, 2012 off Soquel Point with a load of sardines.

On Friday January 6, 2012 at about 0015, the 58' F/V *Stikine* (Figure 1) sank 1.5 miles off Soquel Point (36° 55.717' N, 121° 56.745' W) in 80 feet of water (Figure 2). The vessel sank hull down on sandy bottom habitat with 800-1,000 gallons of marine diesel aboard. All four passengers were rescued. US Coast Guard and Department of Fish and Game OSPR were on scene by 1500 that day with a helicopter, a C-130 aircraft, and a Department of Fish Game vessel to monitor any discharge. A light sheen on the water was observed, and the entire cargo of fuel, along with 50-75 gallons of hydraulic fluid, is believed to have been released at the time of sinking. The vessel had a seine net deployed and it sank connected to the vessel. The boat owner had insurance and contracted with a salvage firm to raise the vessel, but efforts to recover the vessel from the seafloor were unsuccessful due to the position of the net and lead lines, a large load of sardines, and unfavorable weather. In this report we provide a habitat and biological damage assessment of the seafloor.

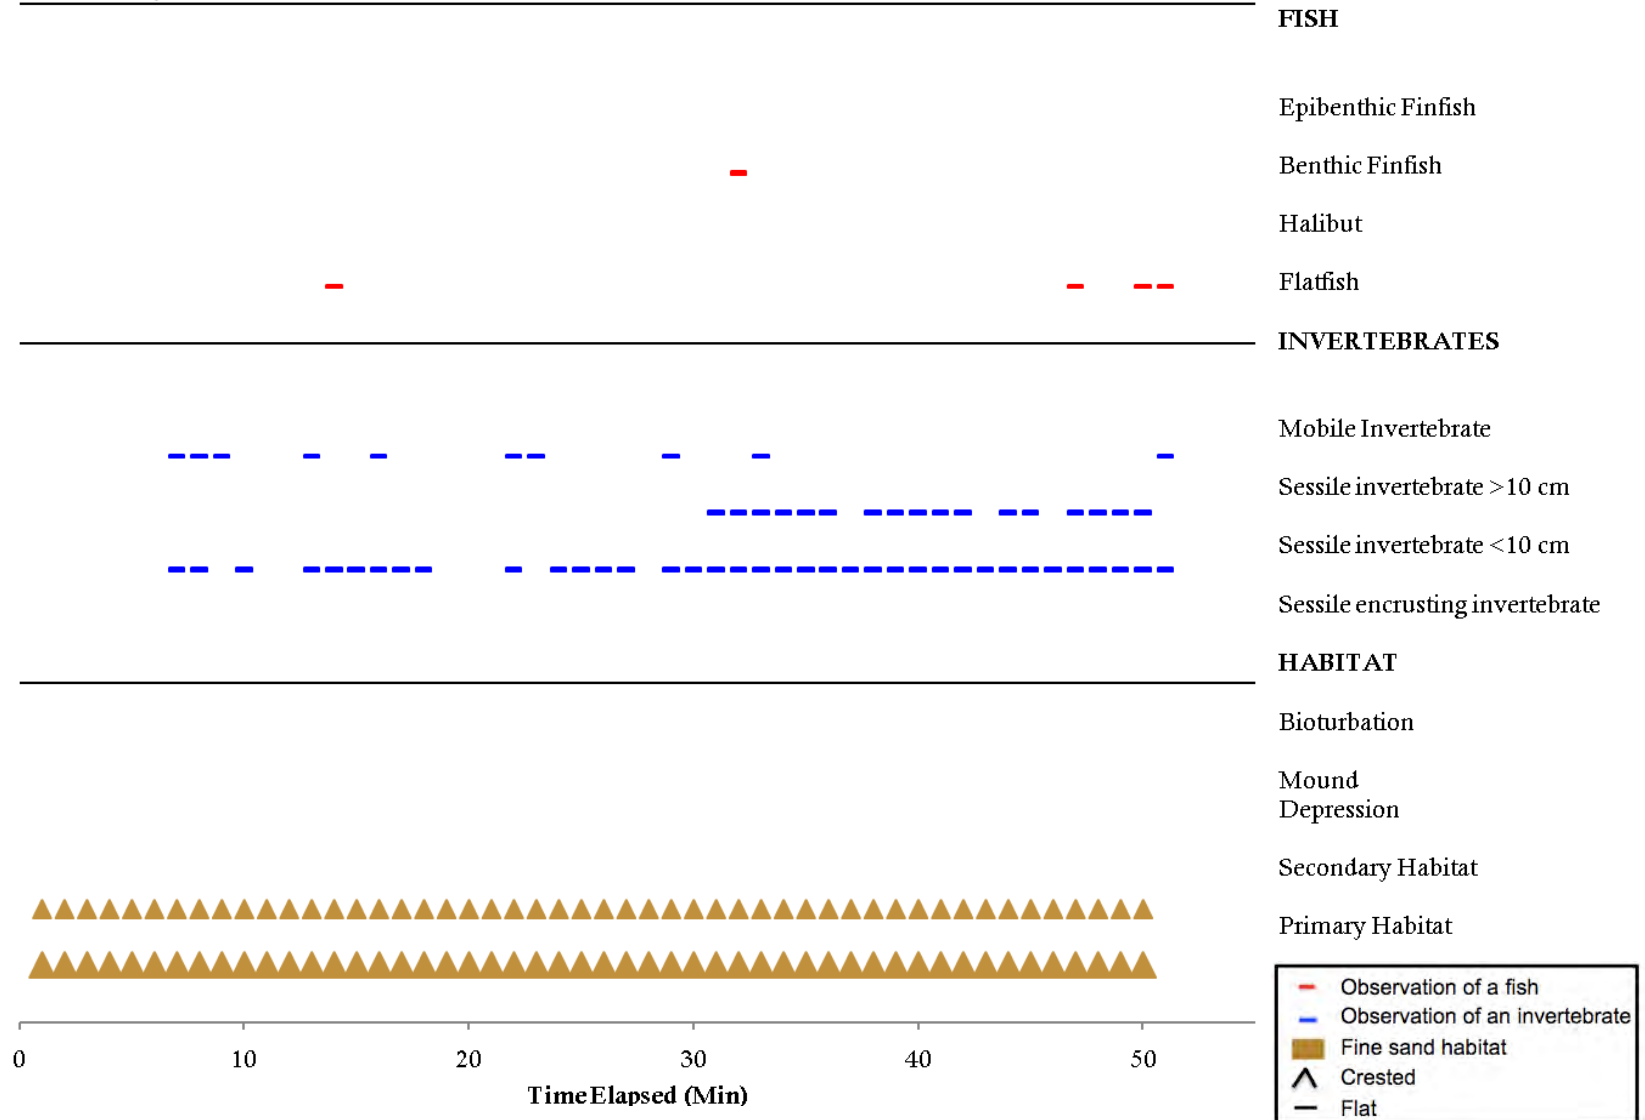
Monterey Halibut Grounds Transect 3

Figure 5. Taxonomic distribution plot for MBNMS/IfAME Transect 3, conducted in 20-30 m water depth. Plot can be read vertically to observe what habitat features and organisms occur at that location, or horizontally to track the distribution of an organism or type across the transect. See Fig. 2 for transect location.

- Taxonomic distribution plots (TDPs) for transects conducted in 20-30 m water depth (Transects 1-4, 6, and 7) illustrate many observations of fish and mobile and sessile invertebrates (Figs. 3-8).

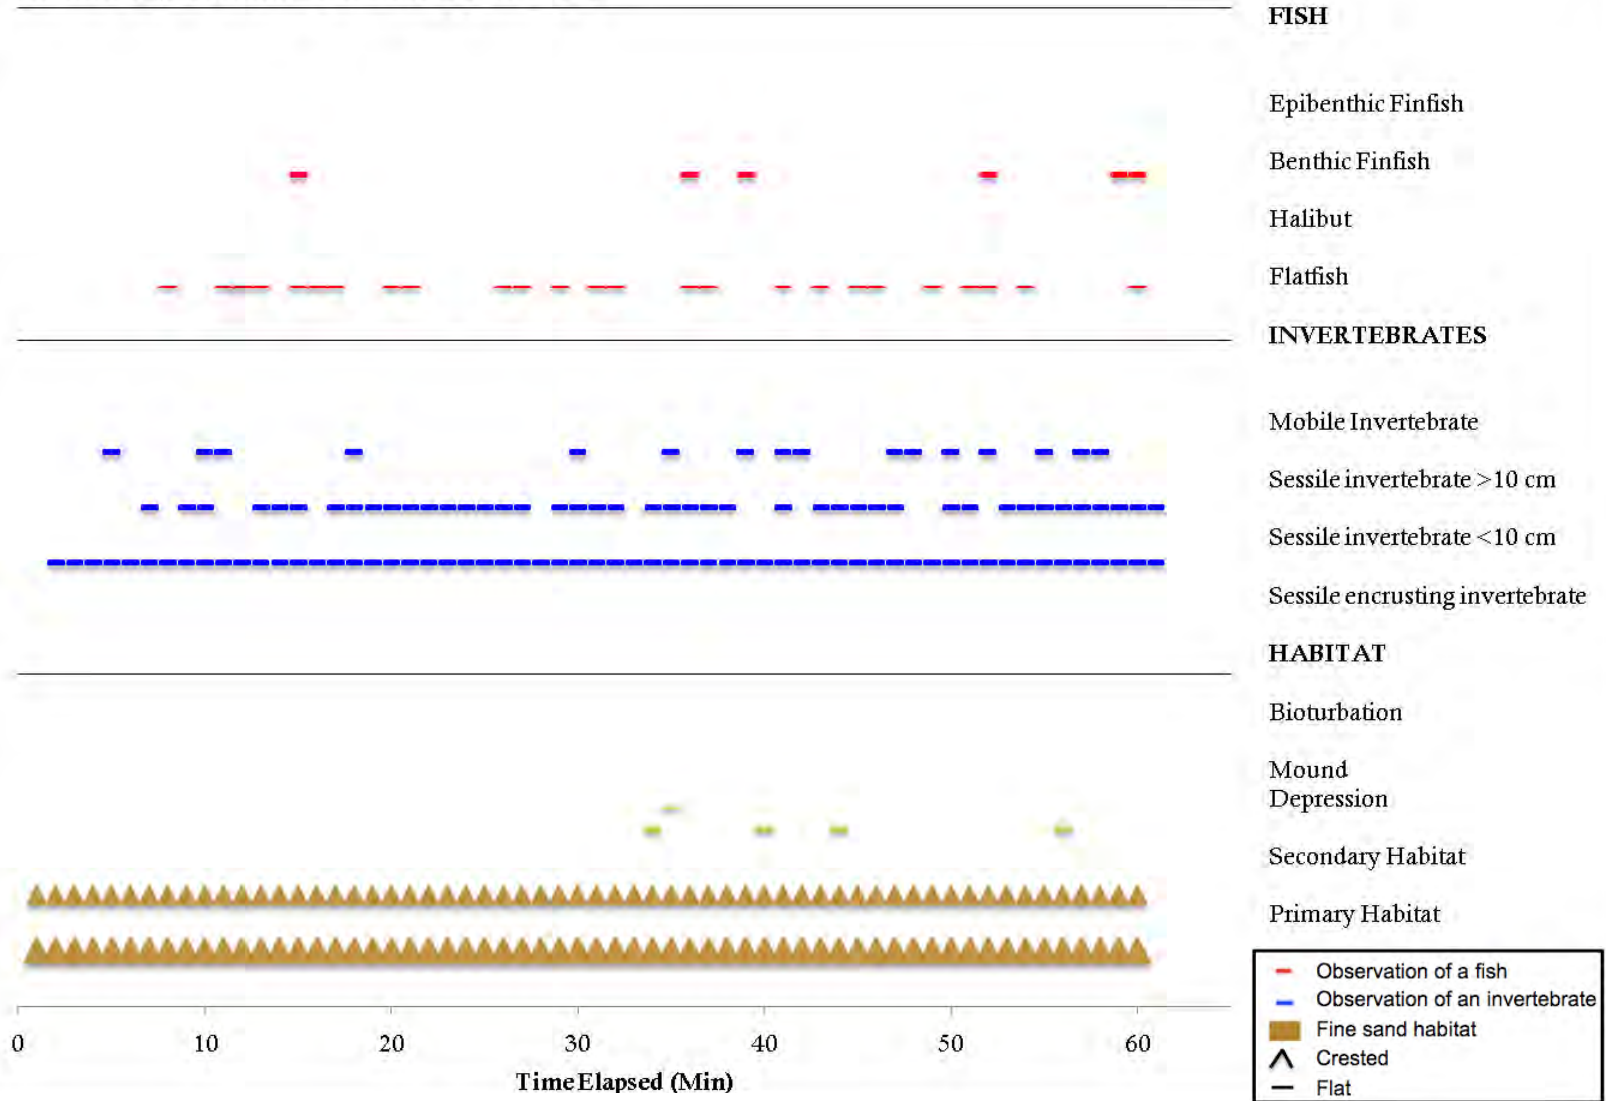
Monterey Halibut Grounds Transect 7

Figure 8. Taxonomic distribution plot for MBNMS/IfAME Transect 7, conducted in 20-30 m water depth. Plot can be read vertically to observe what habitat features and organisms occur at that location, or horizontally to track the distribution of an organism or type across the transect. See Fig. 2 for transect location.
