**Cruise Report for NOAA's
Monterey Bay National Marine Sanctuary &
Northwest Fisheries Science Center Conduct
Autonomous Underwater Vehicle (AUV) Dive Surveys
July 6 through 19, 2017**

Submitted by Karen Grimmer & Sophie de Beukelaer

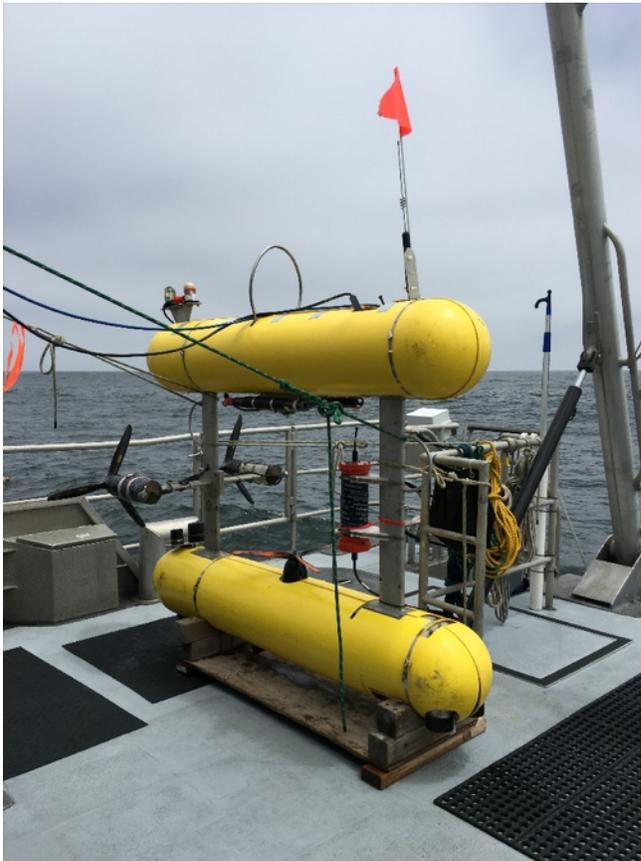
Figure 2. The SeaBED AUV on the back deck of the NOAA Research Vessel Fulmar. The SeaBED AUV is unlike other, more traditional AUV's, in that its twin-hull design provides greatly enhanced stability for low-speed photographic surveys

We used a SeaBED AUV (Figure 2) aboard the *R/V Fulmar* to collect still photography imagery. The SeaBED AUV is owned by the Northwest Fisheries Science Center, is approximately two meters long and weighs nearly two-hundred kilograms. It has two main pressure housings,

a top hull and a bottom hull. The CPU electronics are located in the top hull, the batteries, cameras, and sensors are located in the bottom hull, and all are connected by wet cabling that is routed through vertical struts. With a maximum operational depth range of 2,000 m, SeaBED can be used to survey habitats ranging from shallow coral reefs to deep groundfish environments. This operational depth range may be reduced by other onboard sensor's depth capabilities to a maximum depth of 1,500 m. The AUV has three cameras – one angled camera that shoots oblique photos and two that shoot straight down on port and starboard. The AUV is programmed to fly at an altitude of 3 meters over the seabed and snap images every 8 seconds. For this project we also attached a dissolved oxygen meter to measure any oxygen changes at depth.

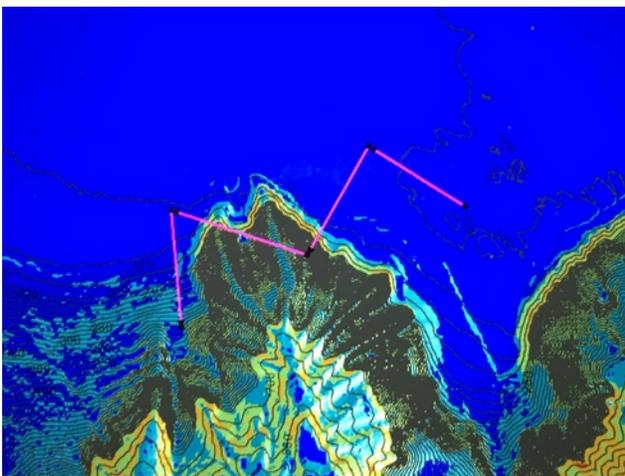
Figure 4. Planned AUV transect at Site 4 (pink lines) over slope map (range of blue to red indicates low to high slope).

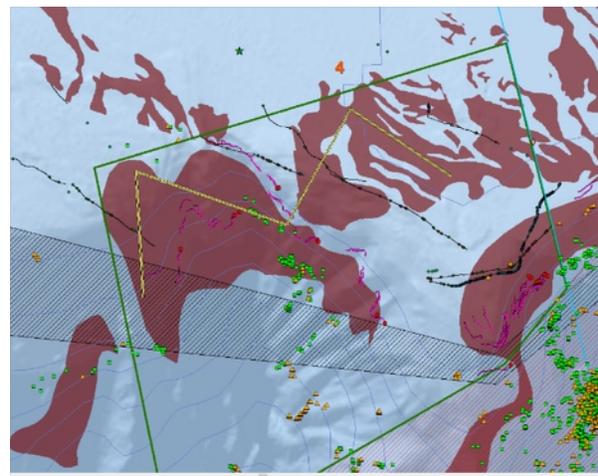
Figure 5. Planned AUV transect (yellow line) over map with hard substrate (brown areas), past research (various colored dots), and management areas (proposed EFH Conservation Area addition and Trawl Rockfish Conservation Area).

The survey at Site 4 transected the Soquel canyon head and then followed the side of the canyon. Ninety-five percent of transect was over hard substrate area (Figure 5). Most of the previous research from CSUMB in this area is within the canyon.

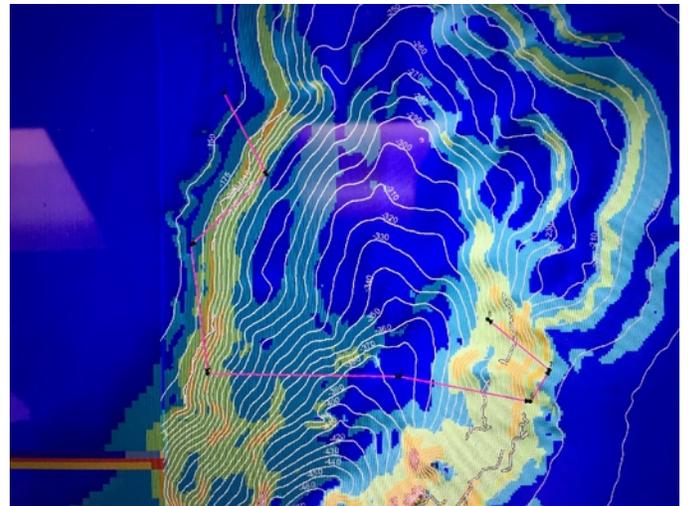
Figure 9. Image of the slope at Ascension Canyon; the pink line is the AUV transect, showing it traversed a variety of depths and slopes during this particular survey (low to high slope is shown in a color range from blue to red).

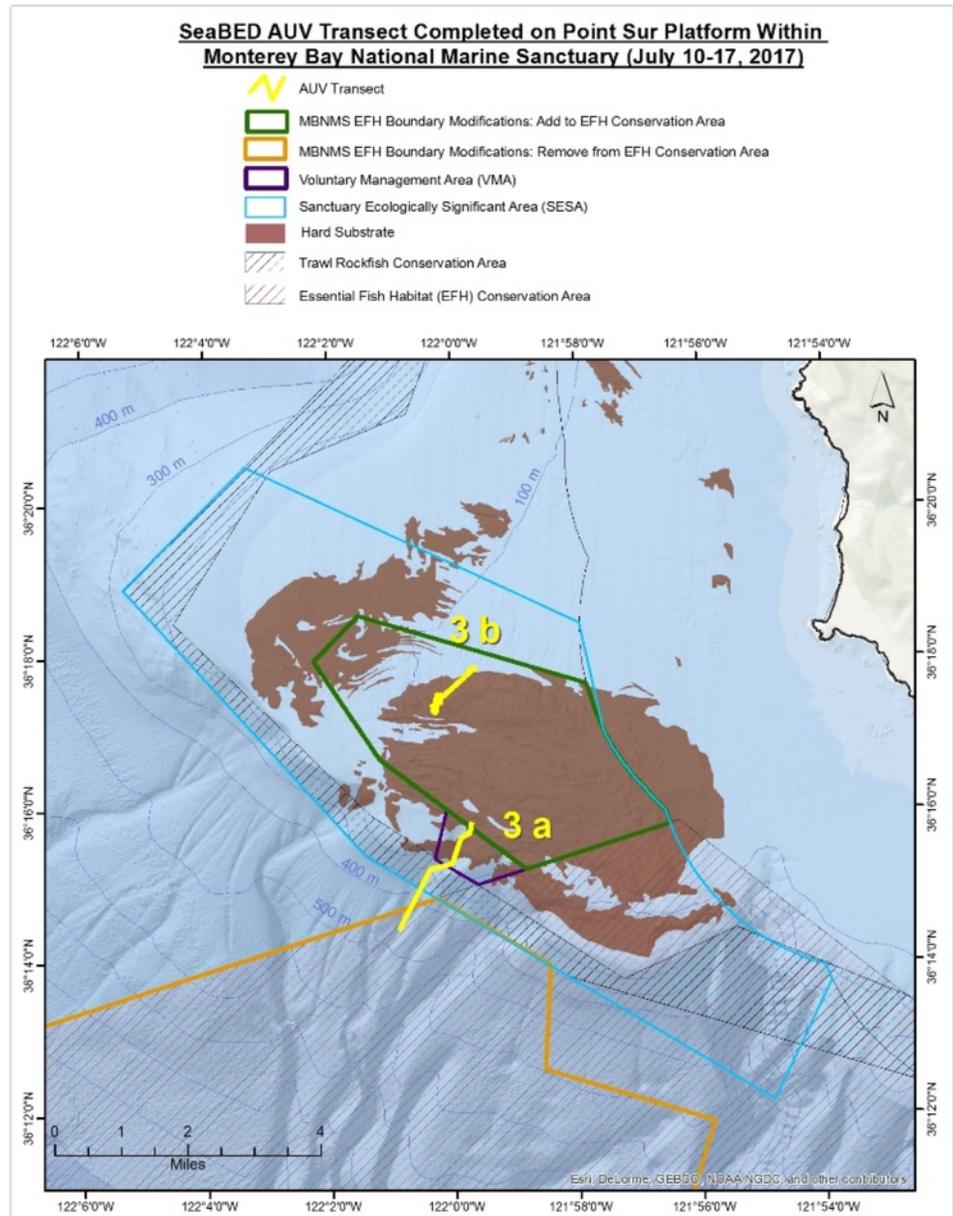
Figure 11. Completed AUV transects at Point Sur.

This area has little if any existing survey information so we were excited to review the images to better understand the habitat and benthic biology in this area. Highlighted images from this dive survey show a remarkable difference in habitat as the slope gets steeper and the AUV moves down into the canyon. The survey started in more shallow waters just south of the main Pt Sur Platform (also known as Schmieder Bank) at about 3 miles offshore, which has mainly rocky habitat, and progressed deeper into soft bottom habitat (Figure 11).

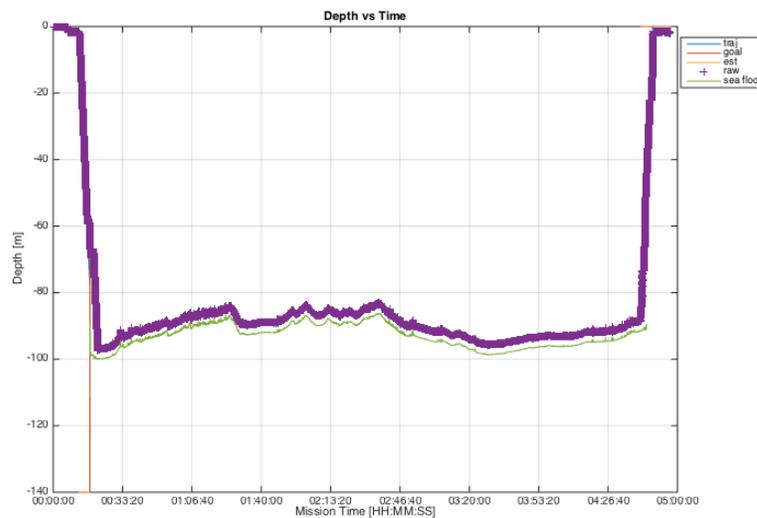
Figure 18. Popoki the AUV follows the seafloor at an altitude of three meters and you can see by this profile how closely she can profile the bottom. The purple line is the AUV and the green line is the seafloor bottom at Site 2.

We started the AUV dive at 8:50 AM to survey Site 2 at Davenport Reef, off Santa Cruz. The survey transect began at 9:05 AM within a proposed EFH closure at a depth of 90 to 100 meters (Figure 18). This area has some existing data from MBARI and CSUMB, and the purpose is to see how the habitat has changed since the last survey.

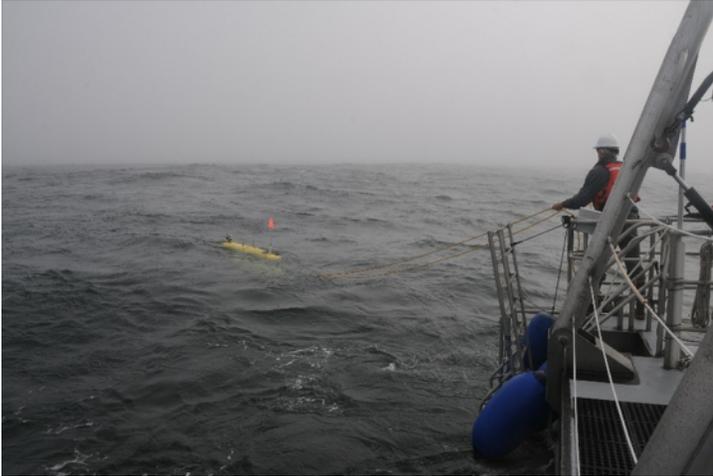
Figure 21. Deployment of the AUV. The AUV is not released until after confirming that we have communication with it to share navigation data.

We departed Monterey in heavy fog at 6:30am and motored to outer Carmel Canyon and deployed the AUV at 7:53am for an almost 5 hour survey dive (Figure 21). This area is proposed to re-open to trawl fishing as the soft sediment slope habitat provides suitable habitat for some groundfish species and it's close to Monterey Bay ports for easier access to fishing grounds (Figure 20 and Figure 22).
