Snapshot Day

May 3rd, 2014

Final Report

Executive Summary

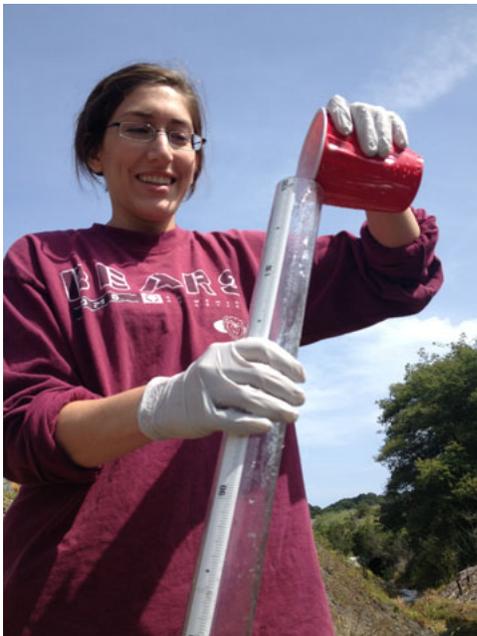
Measuring the transparency at Tembladero Sough in Monterey County.

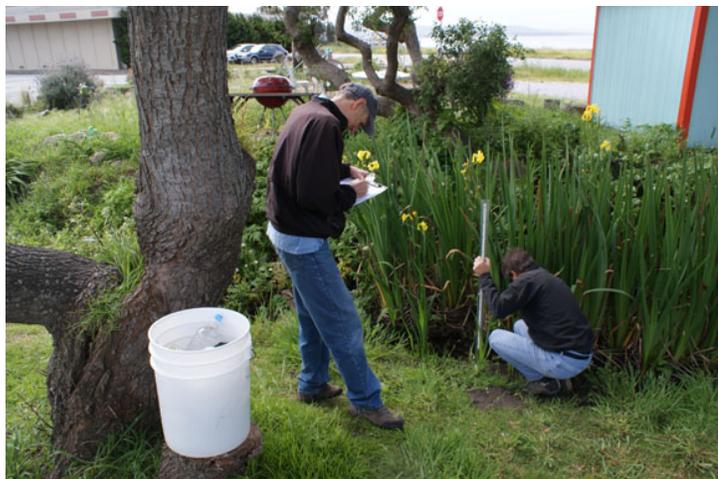
Checking transparency at Deer Creek in San Mateo County.

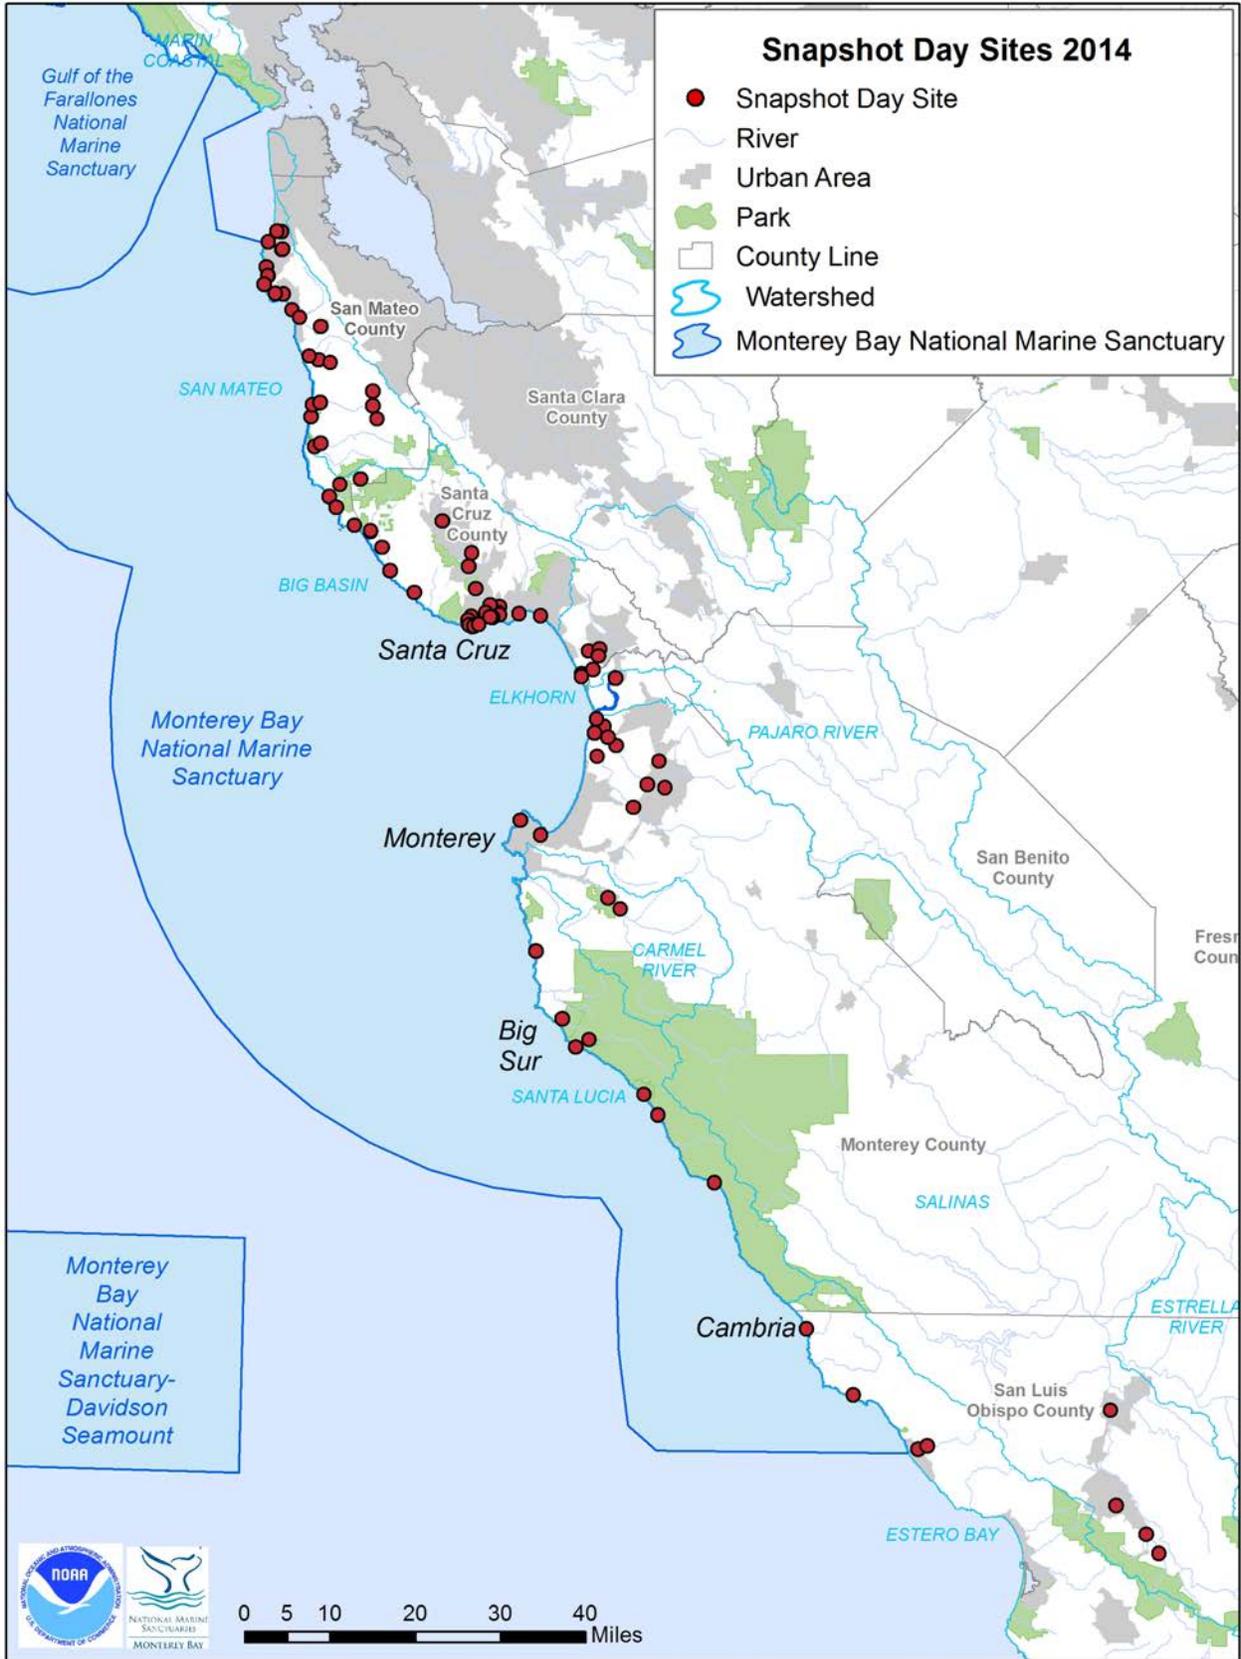
Figure 1. Map of Snapshot Day 2014 monitoring sites

On May 3rd 2014, 133 volunteers gathered at four hubs across the central California coastline. From those four hub the volunteers spread out to monitor 112 sites along creeks and rivers that flow into the Monterey Bay National Marine Sanctuary (MBNMS) (Figure 1). This year, 31% of sites met the water quality objectives for all lab and field parameters.

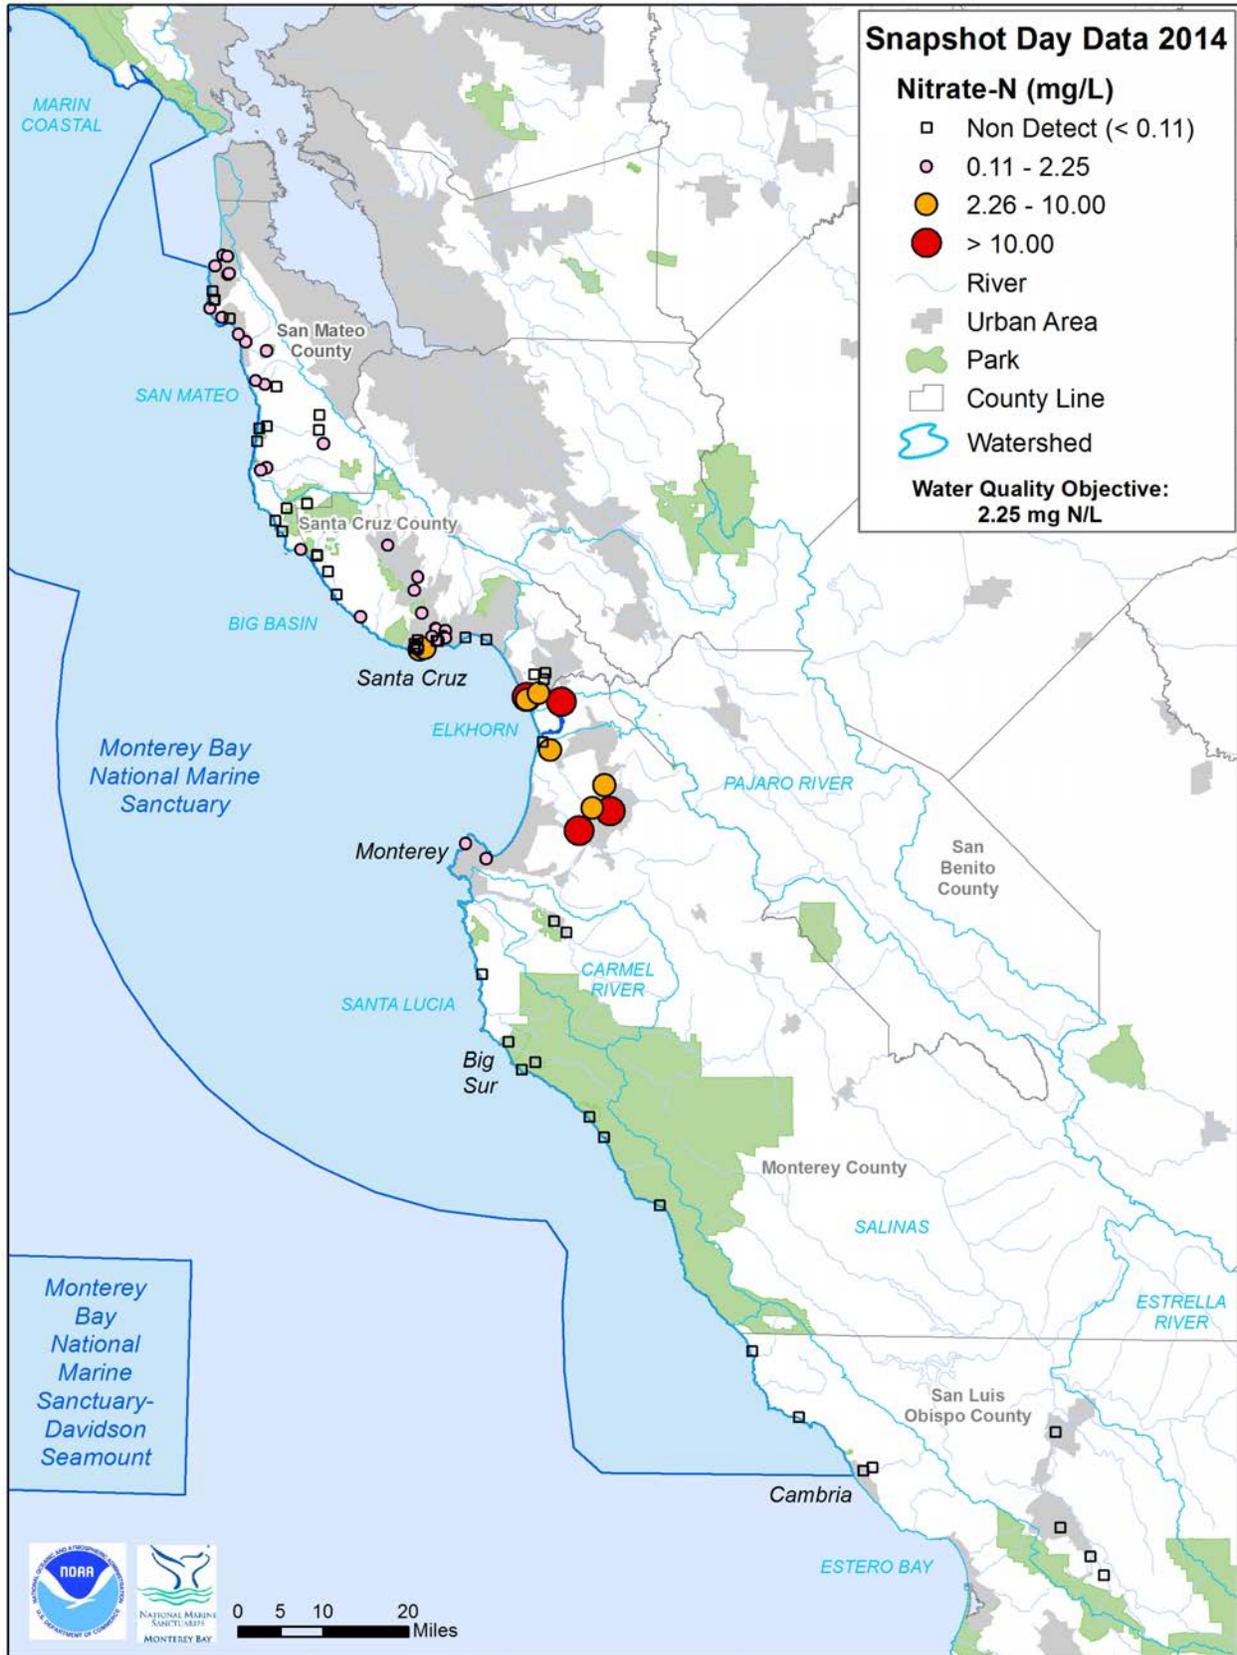
Figure 2. Nitrate as N Results for Snapshot Day 2014.

Fifteen of the sites (16%) exceeded the CCAMP Action Level of 2.25 mg-N/l for nitrate as N (Figure 2). The highest result for nitrate as N was 49.6 mg-N/L in Tembladero Slough at Molera Road (Monterey County). A total of 44 sites (47%) had non-detectable levels of nitrate.

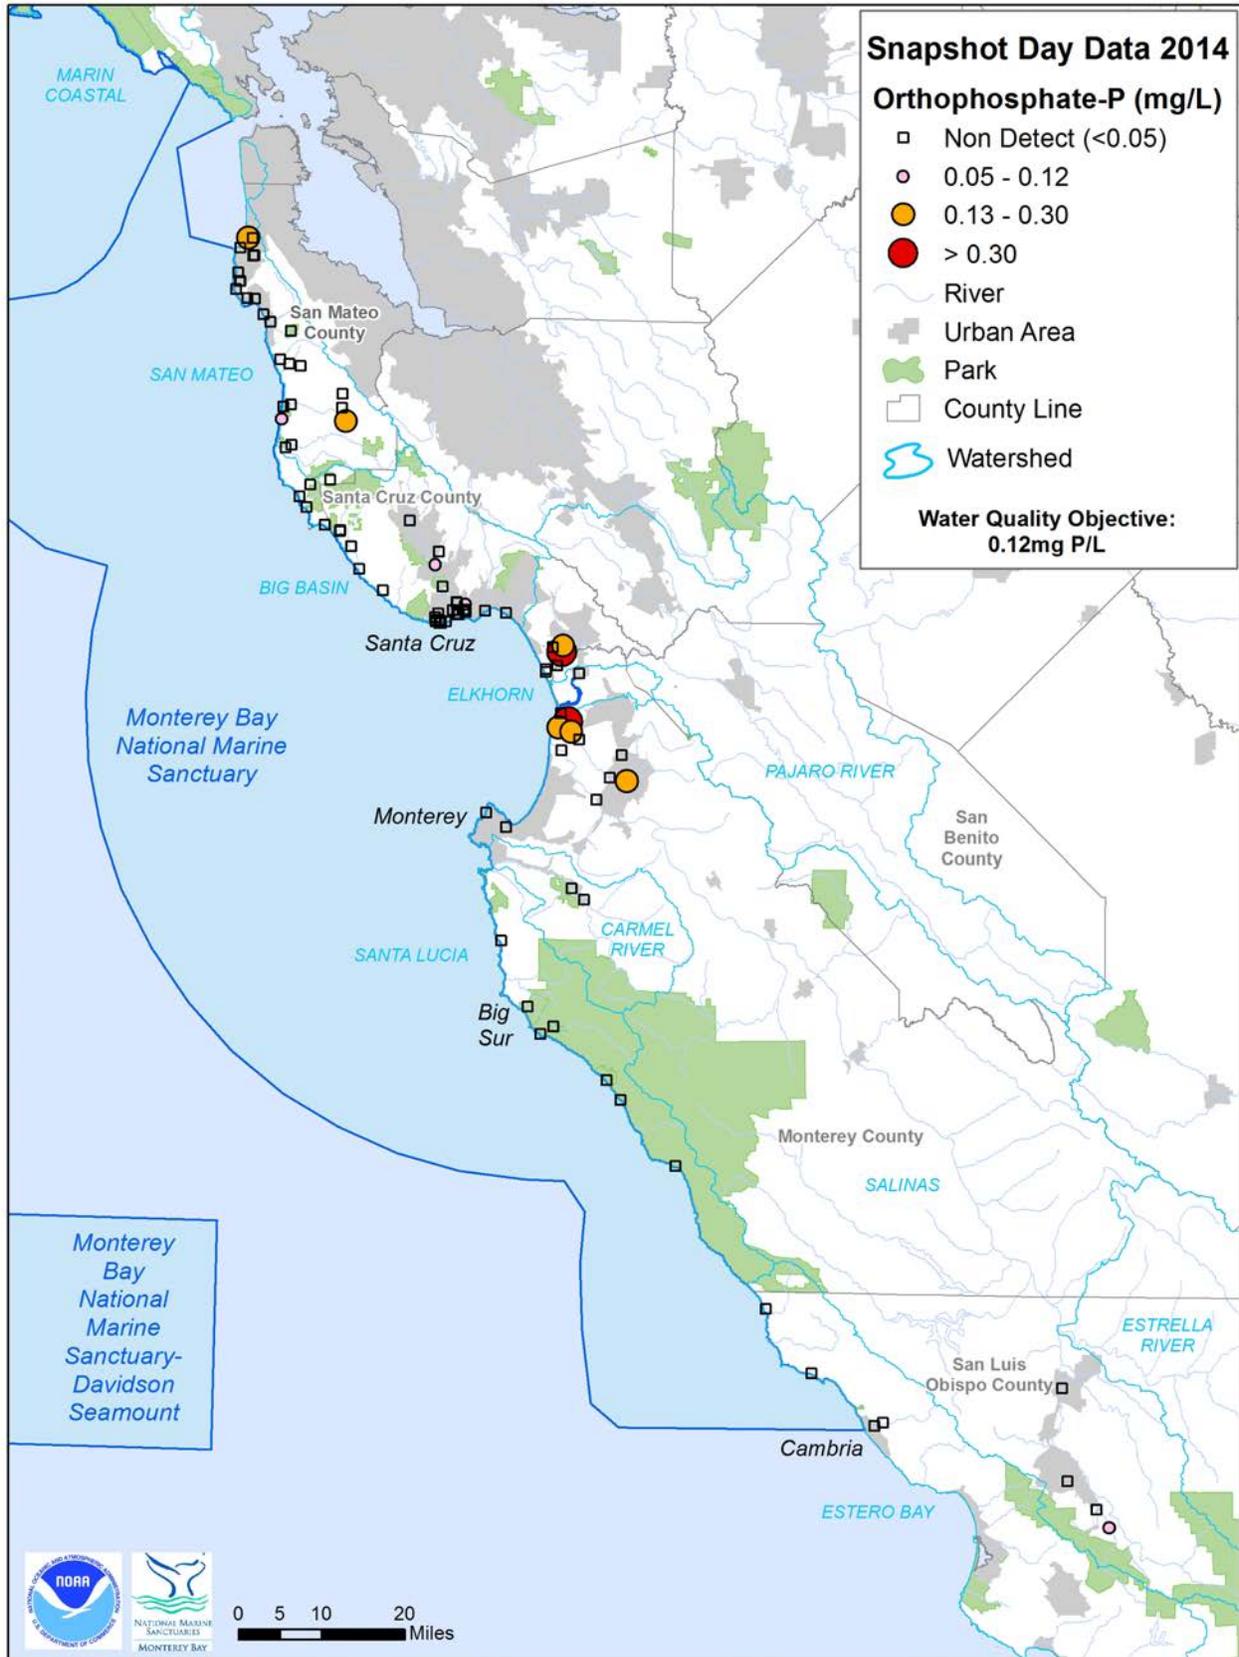
Figure 3. Orthophosphate-P Results for Snapshot Day 2014.

Eight sites (9%) exceeded the CCAMP Action Level of 0.12 mg/l for orthophosphate-P. The highest concentration of orthophosphate was in Struve Slough at Lee Road (Santa

Cruz County) with a concentration of 0.6 mg-P/L. A total of 82 sites (87%) had non-detectable levels of orthophosphate (Figure 3).

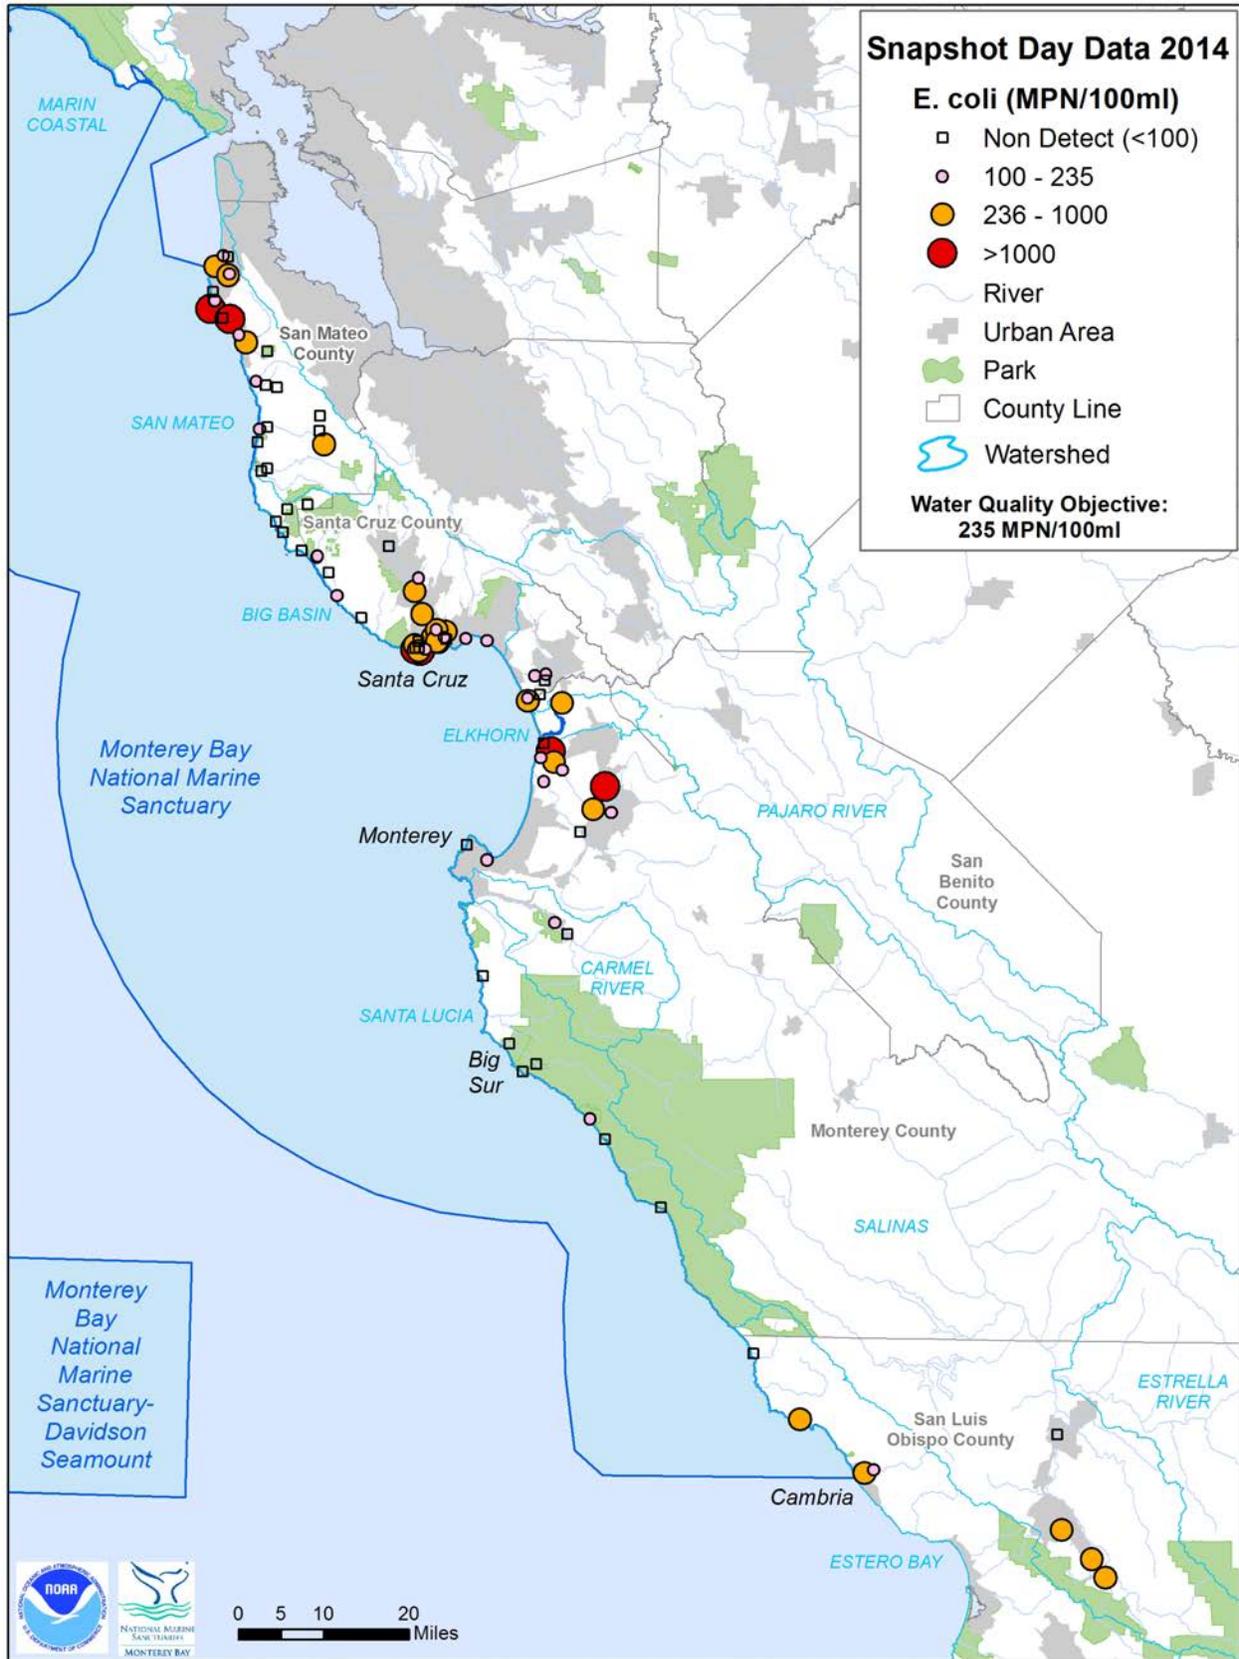
Figure 4. *E. coli* Results for Snapshot Day 2014.

Coliform bacteria generally originate from the feces of warm blooded animals such as humans (from sewage) or wildlife. While coliform bacteria are usually not the cause of sickness, their presence can indicate that other illness causing pathogens are present. The EPA has set a WQO for *E. coli*, at 235 MPN/100ml. Twenty-nine sites (31%) exceeded the *E. coli* WQO on Snapshot Day 2014 (Figure 4). The highest result for *E. coli* was from San Vicente Creek at Cypress (San Mateo County) with a result of 24,196 MPN/100 ml (Figure 8). Thirty-eight sites (40%) had results less than 100 MPN/ 100 ml.

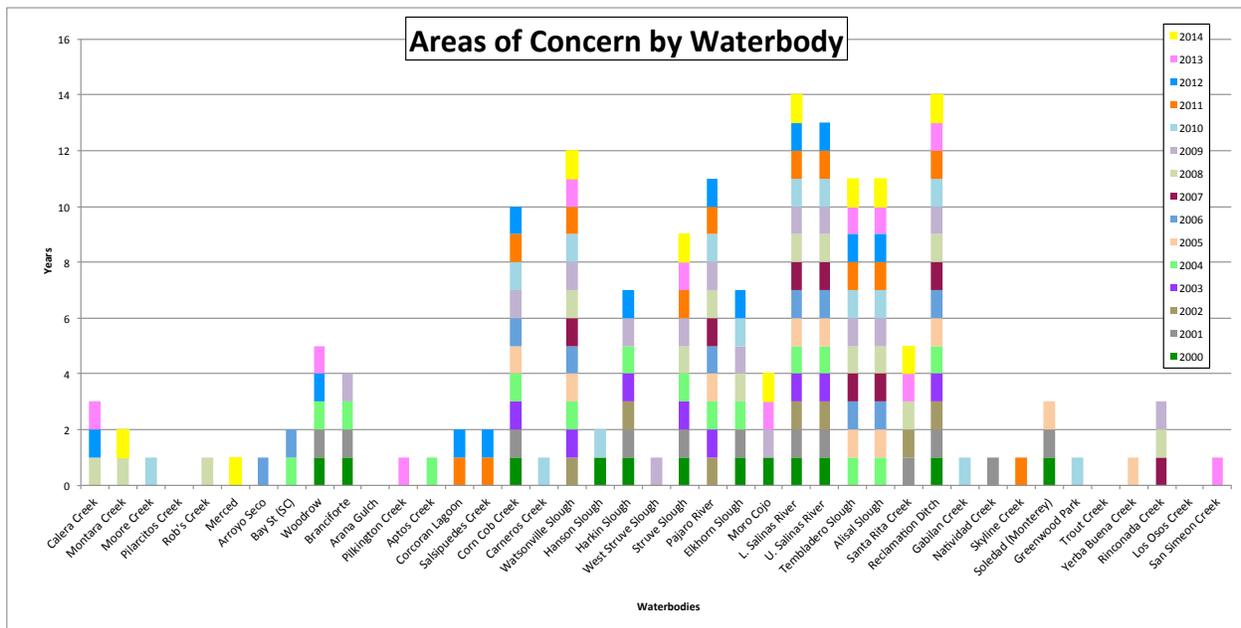
Figure 5. Areas of Concern by water body 2000-2014.

When lab and/or field results for a single site exceed three or more water quality objectives, the site is designated an Area of Concern (AoC). Over the past several years, a trend has emerged of more than one AoC per water body. For example, the Tembladero and Moro Cojo Slough have more than one site that is an AoC along the same waterway. For this reason we have chosen to display the AoC data two ways: by water body (Figure 5) and by site (Figure 6).

In 2014, fourteen sites (15%) were designated Areas of Concern on ten water bodies (Figure 5). For the most part, AoC are designated and stay on the list for many years. This year Montara Creek is on the list for the first time due to exceedances at two sites for dissolved oxygen, pH and transparency (Figure 6). The Lower Salinas River is back on the AoC list again after a one year break. The Lower Salinas River site had exceedances in dissolved oxygen, temperature and nitrate as N. All data is available in Appendix 1.
